## Master's Thesis

**Study of the seismic vulnerability of  
Catalonian Romanesque churches:  
the churches of the monasteries of  
Santa Maria de Poblet and  
Sant Miquel de Cruïlles**

UNIVERSITAT POLITÈCNICA  
DE CATALUNYA

University of Minho

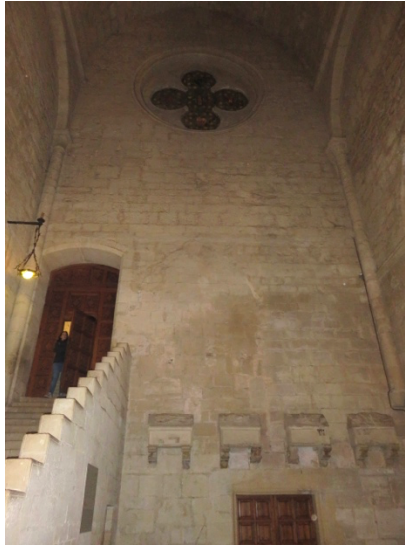
Figure 2.7.7. Poblet north transept facade, from the interior

The transept is considerable in size. The north transept adjoins the monk dormitories and the south transept supports a small bell tower. The transept facades have a decorative window at the top. The north side appears to have a small section in the middle that was once an opening but was later filled in (Figure 2.7.7).

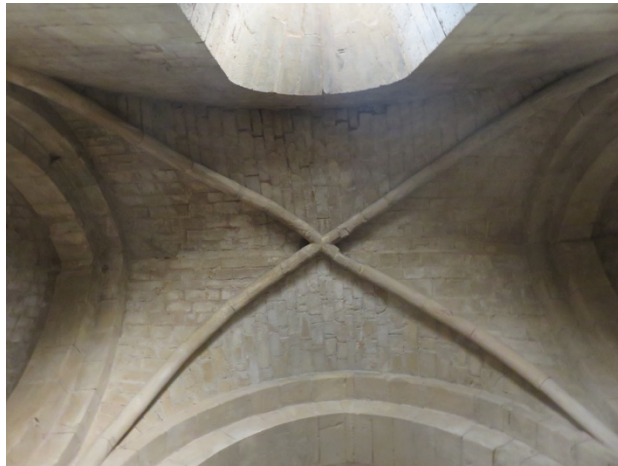
Figure 2.7.16. Fifth vault from transept, north aisle

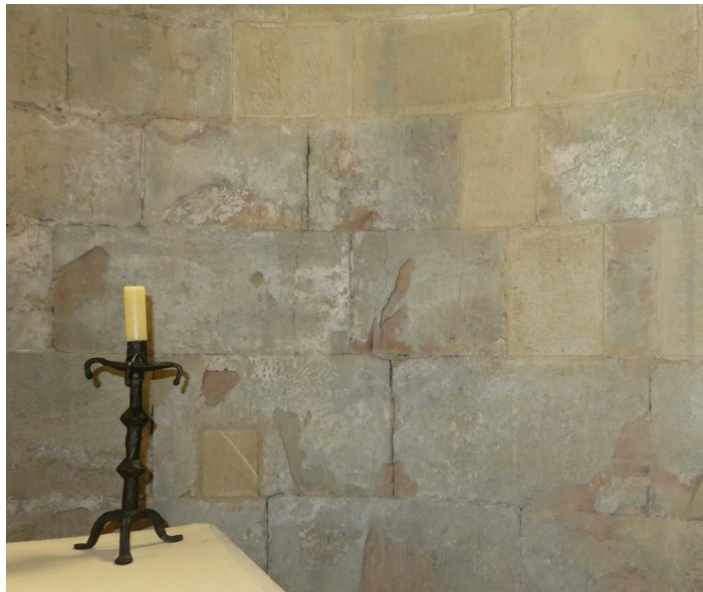
Figure 2.7.17. Thin cracks in chapel wall and spalling of stones

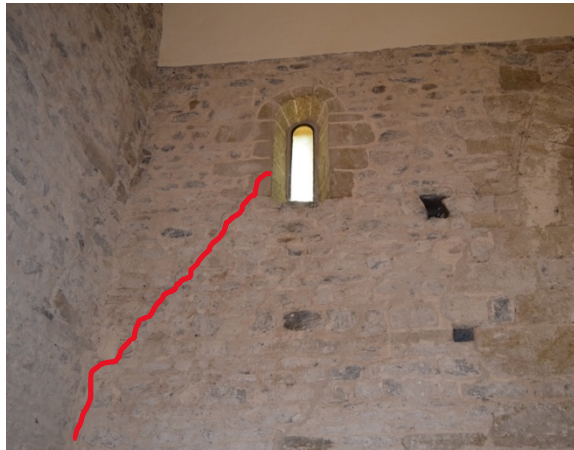
Figure 2.8.11. Diagonal cracking in east wall of north transept

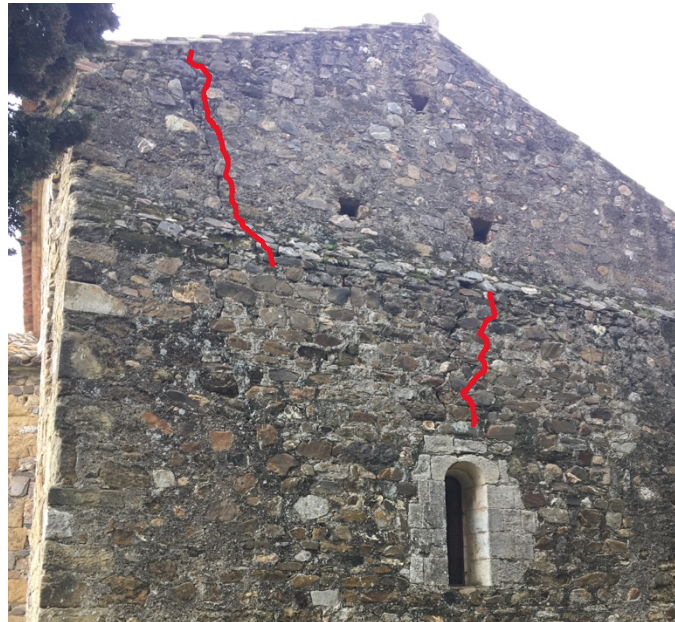
Figure 2.8.13. Cracks in exterior of north transept facade of Sant Miquel de Cruïlles

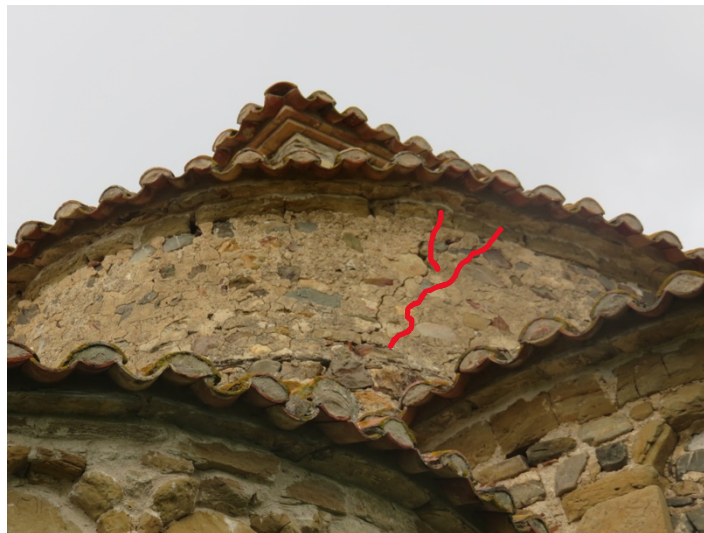
Figure 2.8.14. Crack in drum of Sant Miquel de Cruïlles

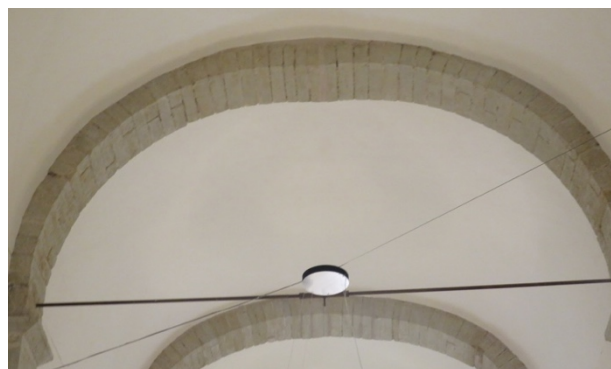
Figure 2.8.16. Slight deformation of the key of the first arch from the crossing
